# Full scale testing results of structural damage detection using long gage fiber Bragg gratings and modal analysis

Sean Calvert<sup>\*a</sup>, Joel P. Conte<sup>\*\*b</sup>, Babak Moaveni<sup>b</sup>, Whitten L. Schulz<sup>a</sup>, Raymond de Callafon<sup>c</sup>  
<sup>a</sup>Blue Road Research; <sup>b</sup>Dept. of Structural Engineering, <sup>c</sup>Dept. of Mechanical & Aerospace Engineering, University of California, San Diego

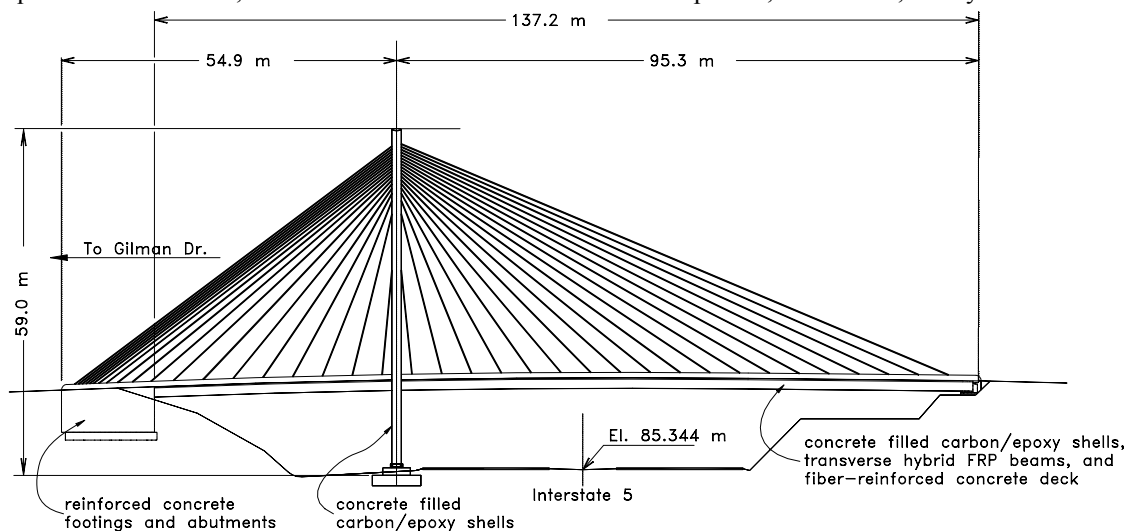
Figure 1. Elevation of I-5/Gilman Advanced Technology Bridge<sup>6</sup>

The I-5/Gilman Advanced Technology Bridge currently in planning consists of a 137m (450 ft) long cable-stayed bridge supported by a 59m (193 ft) high A-frame pylon (Figure 1). This bridge utilizes fiber reinforced polymer composite materials. In order to validate the design and evaluate the performance of the I-5/Gilman Advanced Technology Bridge, a Validation Test Program was conducted in the Charles Lee Powell Structural Research Laboratory at the University of California San Diego. The objectives of this prototype test program were to evaluate the manufactured FRP components at the material level, through coupon testing and other non-destructive techniques on the members, and at the element level on full-scale component, connection, and system tests<sup>6</sup>.

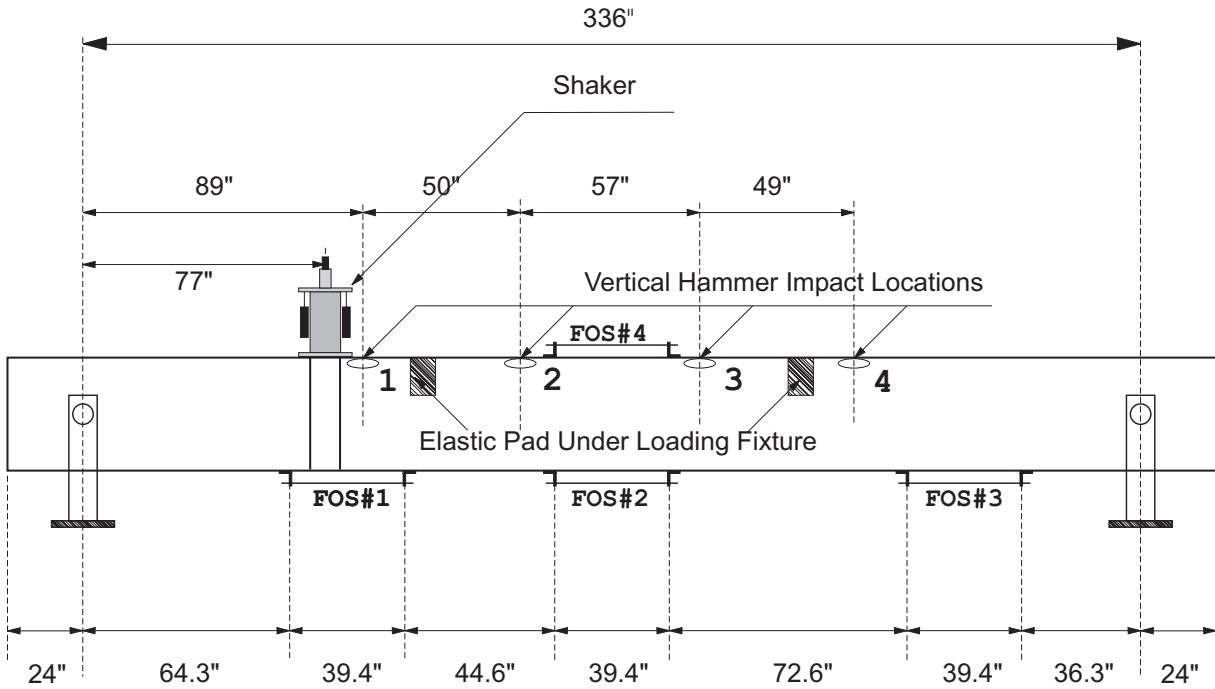
Figure 3. Locations of fiber optic sensors (FOS) and vertical hammer hits along the girder.

The modal frequencies and damping ratios estimated from the accelerometer measurements are given in Table 2 for the first four vibration modes at seven damage states. Damage states 0 and 1 characterize the state of the girder before the start of the quasi-static loading experiment and thus represent the undamaged state of the beam. The same modal parameters identified from fiber Bragg grating measurements are shown in Table 3 for damage states 1 through 5. It is noted that the modal identification results obtained from accelerometer data and fiber Bragg grating sensor data are in excellent agreement. The agreement is not as good for the modal damping ratios as for the modal frequencies. However, in system identification, it is well known that the estimation error is inherently significantly larger for damping ratios than for modal frequencies. The parametric system identification results in Tables 2 and 3 are also in very good agreement with the non-parametric results in Table 1. The first four mode shapes identified using accelerometer measurements (seven accelerometers along bottom of the girder) are plotted in Figure 11 for damage states 1, 3, 4, and 5. It is observed that the mode shapes do not vanish at the supports, which is probably due to the fact that the support structures are not rigid relative to the high stiffness of the girder. The first four modal macro-strain vectors<sup>3</sup> identified using fiber Bragg grating sensor measurements are shown in Figure 12 for damage states 1, 3, 4, and 5. The fiber Bragg grating sensors are numbered as shown in Figure 3.

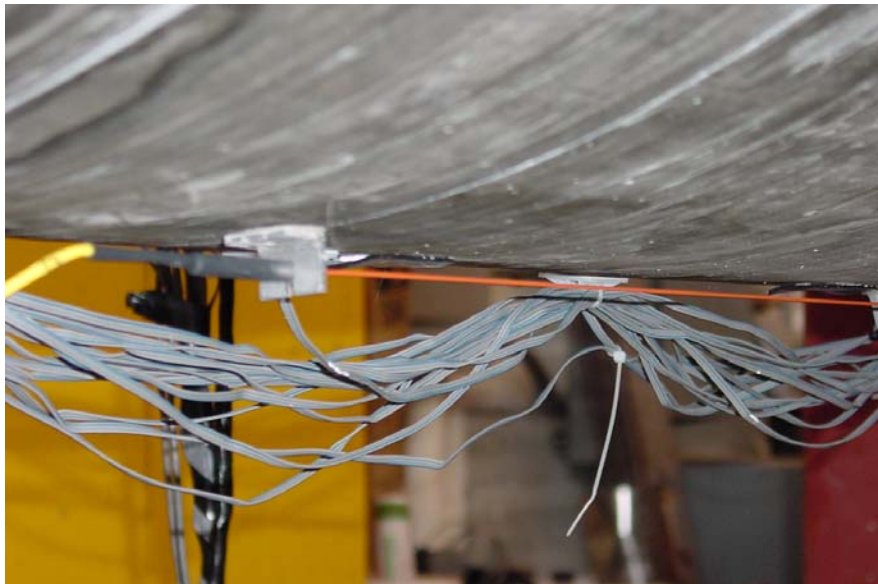
Figure 4. Long-gage fiber grating sensor surface mounted with brackets along bottom edge of girder.

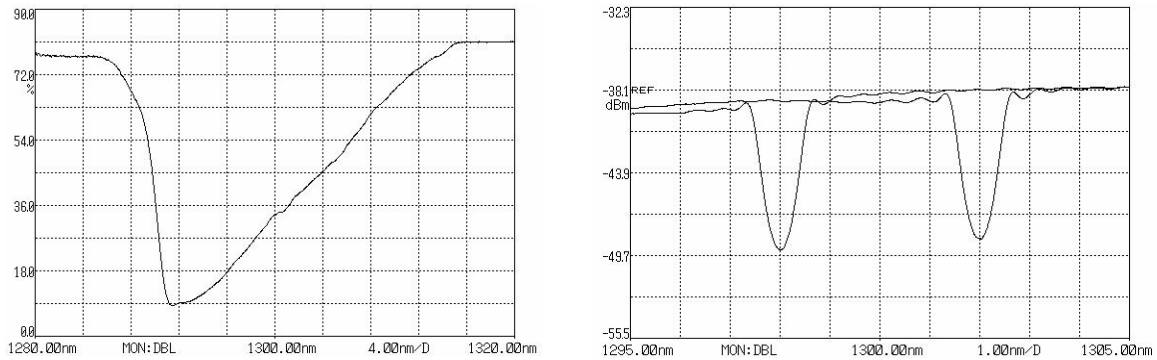
Figure 5. Comparison of spectral filters in the high-speed demodulation system. The chirped grating (left) provides a wide dynamic range and a lower sensitivity (change in amplitude per wavelength shift), while the tunable filter (right) provides high sensitivity with a lower dynamic range capability.

The high-speed requirements of the test (approximately 1kHz) dictated the use of a high-speed fiber Bragg grating demodulation system. The system used employs a spectral filter to convert the spectral information from the Bragg grating into an amplitude-based signal measured by high-speed photodetectors. The unique challenge for this particular test was that the high-speed macro-strain measurement was in conjunction with the relatively large girder deflections from the four-point bend test. Of the two current options of spectral filters for the high-speed demodulation system, the chirped grating filter provides a wide measurement range at the expense of sensitivity, and the tunable grating filter provides high sensitivity with a more limited measurement range (Figure 5).

In order to maximize the sensitivity of the optical measurement, the tunable filter was chosen. This dictated a compromise in the testing; the sensors were removed during the quasi-static large deflection bending of the girder and replaced for the small displacement high-speed (dynamic) tests. As explained in Section 4, the dynamic tests were performed between sequences of quasi-static loading-unloading cycles. The four channel demodulation system is shown in Figure 6. A single broadband light source was used to illuminate all four grating sensors. To reduce the number of connections required, a coupler module was constructed that directed the input from the light source to each of the sensors and in turn directed the spectral reflections from the sensors to the spectral filters and the detectors.

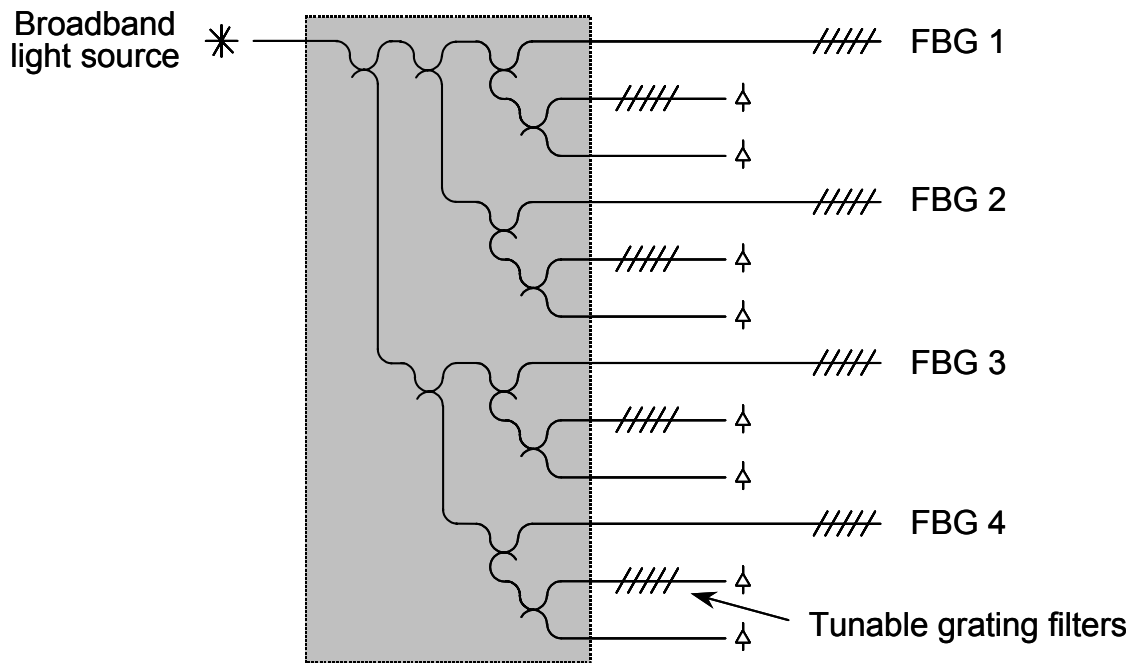
Figure 6. Four channel, high-speed fiber Bragg grating demodulation system

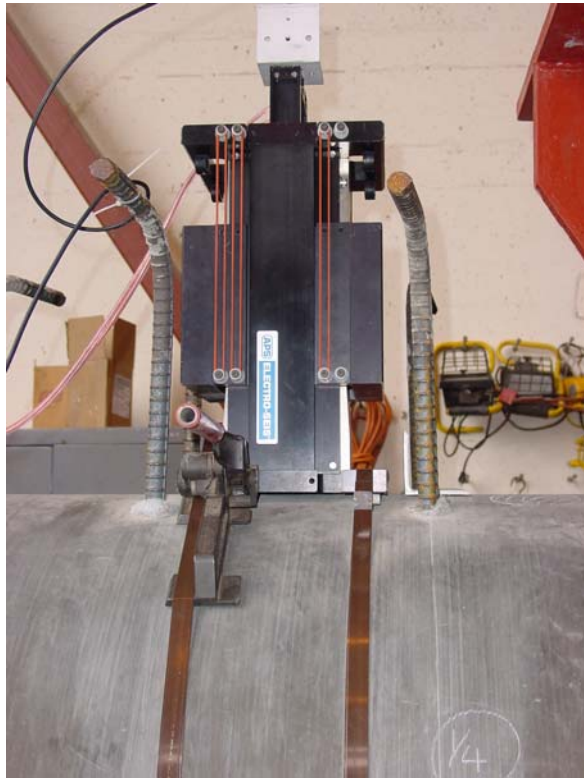
Figure 7. Electro-dynamic shaker strapped to the girder

Each sequence of dynamic tests consisted of a set of forced vibration tests using a 50 lbs force electro-dynamic shaker shown in Figure 7, followed by a set of free vibration tests using an impact hammer shown in Figure 8. The forced vibration tests using the shaker consisted of a set of sixteen (Gaussian) white noise excitations followed by three (linear) sine sweeps in the frequency ranges [12 - 22 Hz], [38 - 48 Hz], and [93-103 Hz], which contain the first three beam natural frequencies. The free vibration tests using the impact hammer with integrated load cell consisted of three “vertical” impact tests at each of four locations along the top edge of the girder. From the fifth sequence of dynamic tests, which corresponds to damage state 4, a single “horizontal” impact test at each of four locations along the beam was performed.

<sup>a</sup> The technical characteristics of the electro-dynamic shaker used in these experiments are: Manufacturer: APS Dynamics Inc., Model 113, Frequency range: 0 to 200 Hz, Maximum dynamic force: 42 lb.

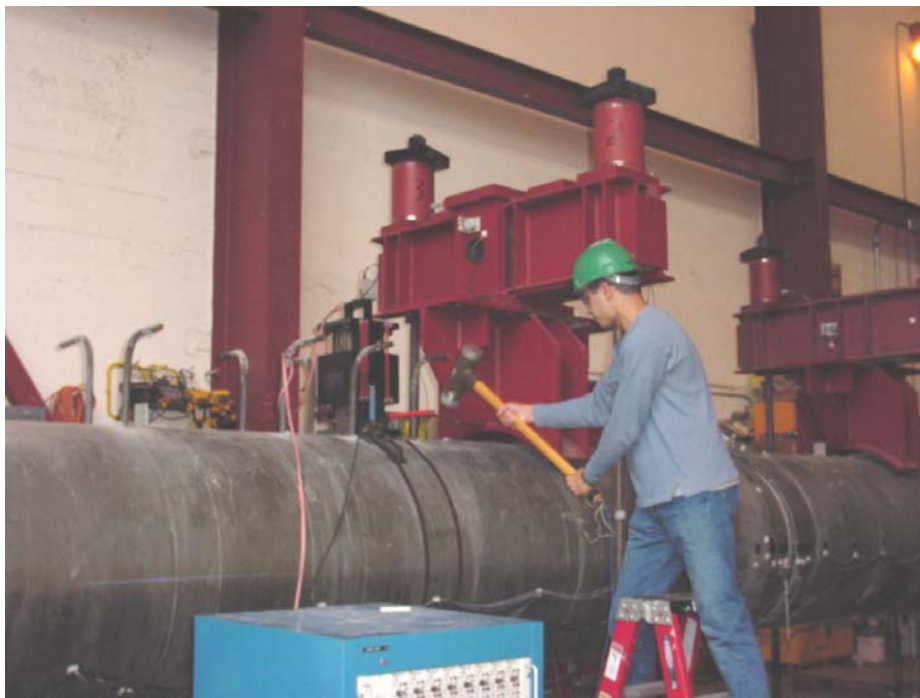
Figure 8. Impact hammer test on the girder

<sup>b</sup> The impact hammer used for these experiments has the following characteristics: Model PCB 086 C50, amplitude range 0-22 KN, mass 12 lbs, frequency range 0.5 kHz.

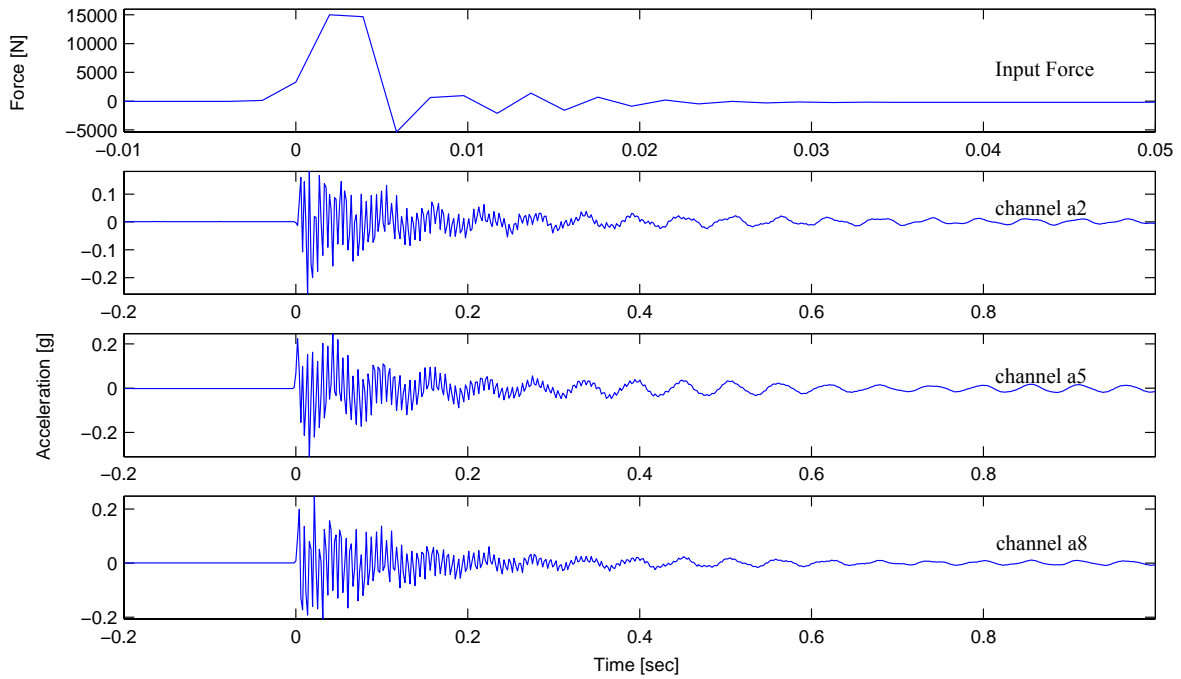
Figure 9. Input force and acceleration response histories at three channels for the first hammer hit at location 1 for damage state 1.

The beam's response to dynamic excitation was measured by eight accelerometers and four fiber Bragg grating sensors for several damage states. As illustrative samples of measured data, accelerometer and fiber Bragg grating response time histories are shown in Figures 9 and 10, respectively.

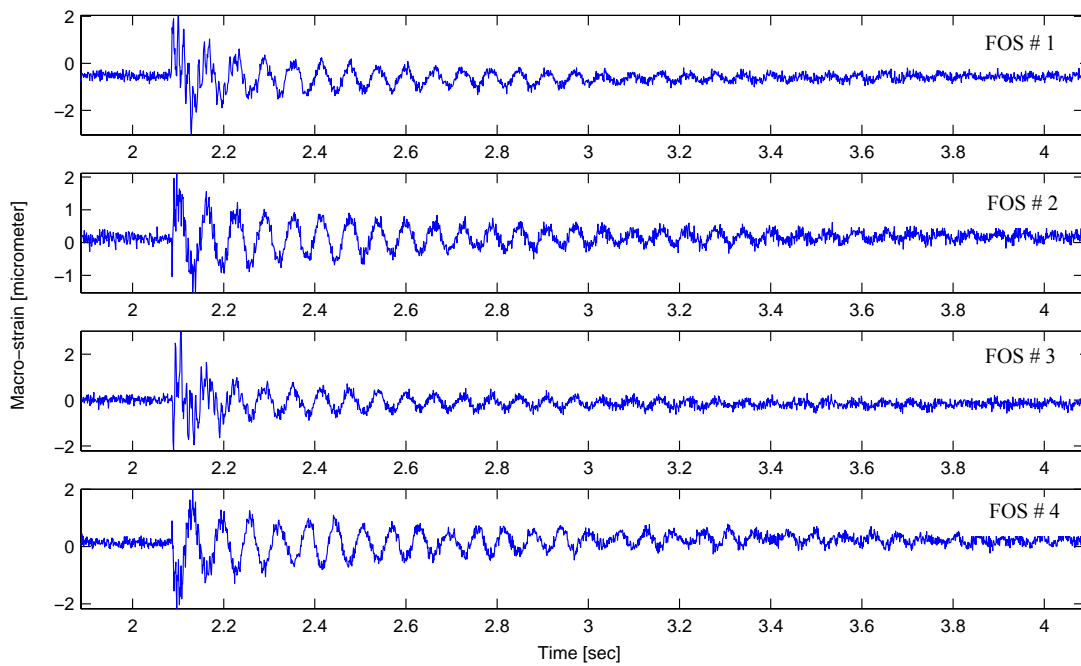
Figure 10. Macro-strain response histories for the first hammer hit at location 1 for damage state 1.

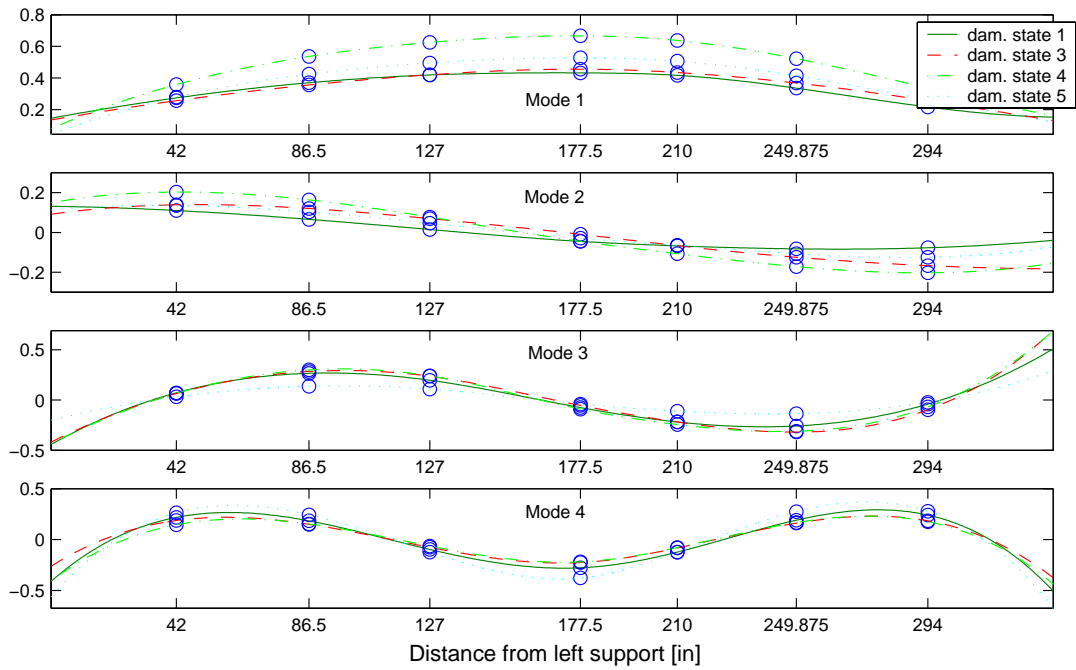
Figure 11. The first four vibration mode shapes identified from accelerometer data for impact test at various damage states.

As the damage level of the girder increases, the modal frequencies decrease as shown in Tables 1 through 3, and the mode shapes and modal macro-strain vectors exhibit changes. These changes in identified modal parameters (or modal features) can be used for the purpose of structural damage identification (i.e., damage detection, localization, and quantification). Application of damage identification techniques to this set of experimental data is underway.
